Revetment Stability Tests for Sargent Beach, Texas

by *Robert D. Carver, Willie J. Dubose,
John M. Heggins, Brenda J. Wright*
Coastal Engineering Research Center

CERC-93-

Final report

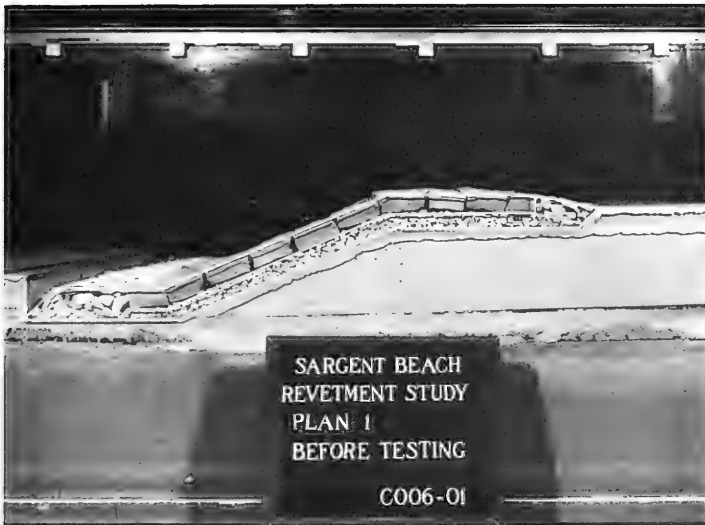
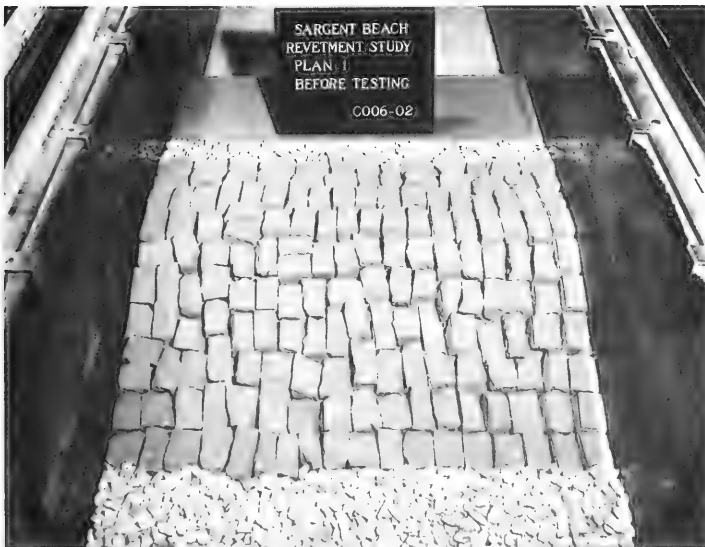
Photo 1. Side view of Plan 1 before wave attack

Photo 2. Sea-side view of Plan 1 before wave attack

Plan 1 (Figure 4 and Photos 1 and 2) was constructed to a crown elevation of +7-ft mlt and used an armor slope of 1V on 2.5H. A crown width of 20 ft, equivalent to four armor-stone diameters, was used. The 5-ton armor stones (specific weight ≈ 165 pcf), which are approximately 2.5-ft thick, 4-ft wide, and 6-ft long, were specially placed with the 2.5-ft dimension perpendicular to the slope. The majority of the stones were also placed with their long axis perpendicular to the wave crest (upslope). It was assumed that this orientation would minimize uplift forces.

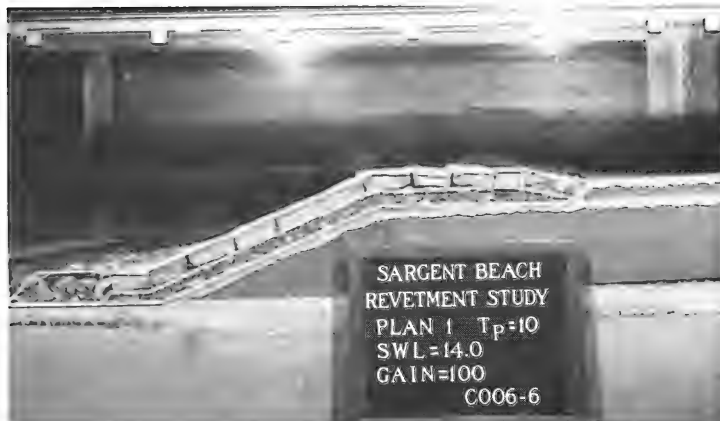
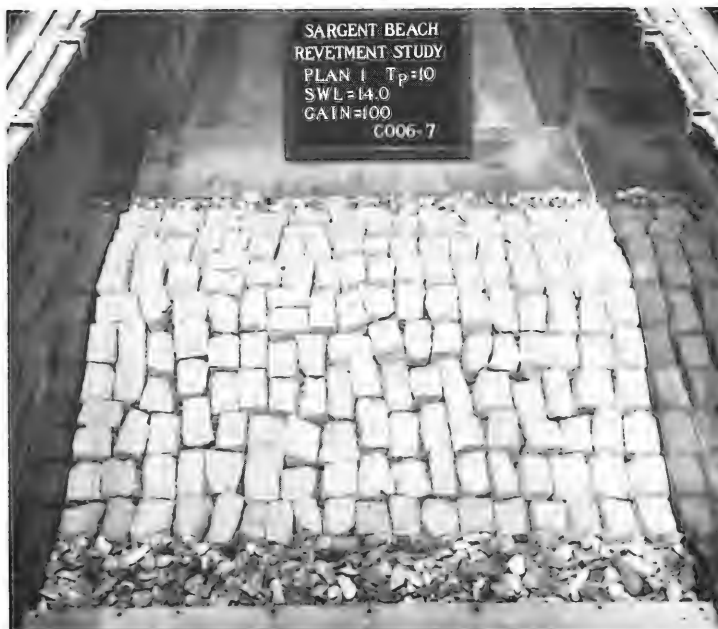
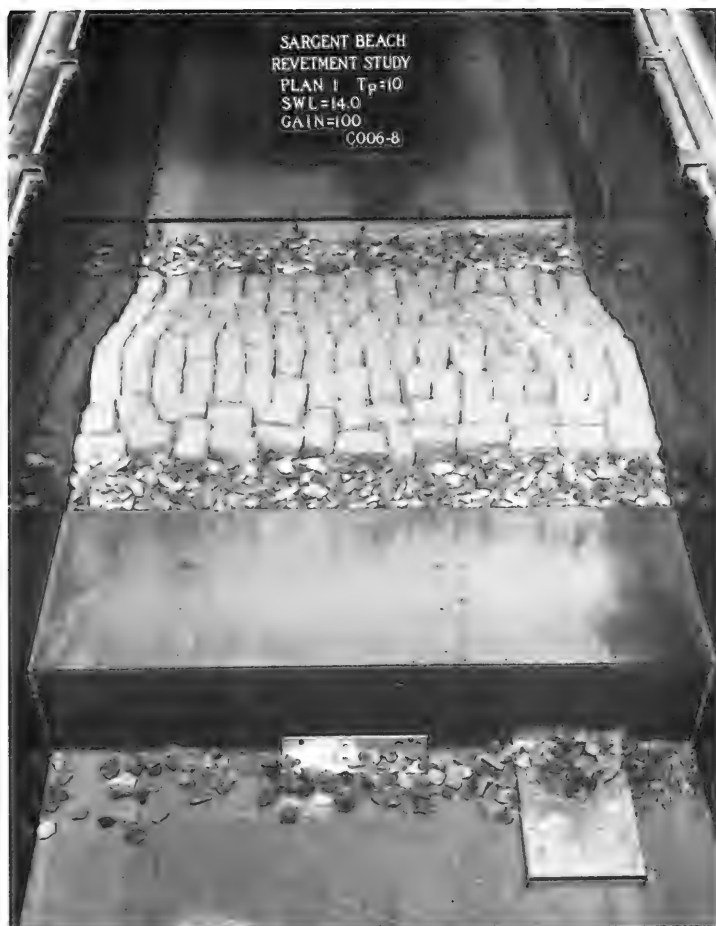
Photo 3. Side view of Plan 1 after wave attack

Photo 4. Sea-side view of Plan 1 after wave attack

Photo 5. Land-side view of Plan 1 after wave attack

Plan 1 was subjected to the 24-step test delineated in Table 1. Some landward displacement from the shore-side crest of the structure of the 200- to 1,000-lb stone was observed at the +4-ft swl. Minor reorientation of some 200- to 1,000-lb toe stone also was observed. No armor stone movement was detected. The +7-, +9.5-, and +14-ft swl's supported progressively larger waves; however, much of this energy passed over the structure and only two additional 200- to 1,000-lb stones shore-side of the crest were displaced. Photos 3-5 show the after-testing condition of the structure.

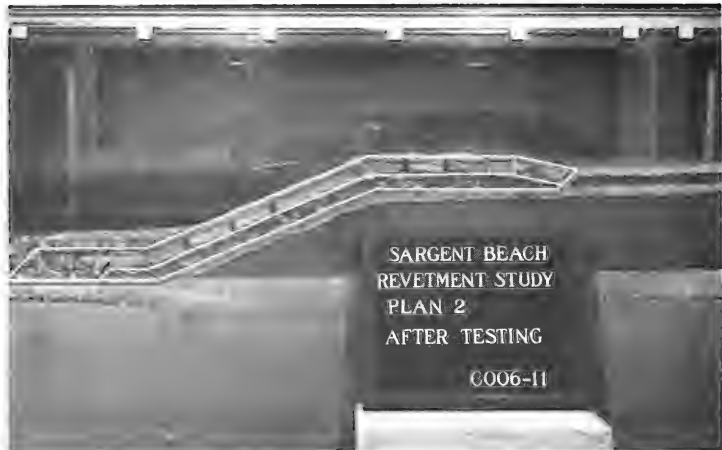
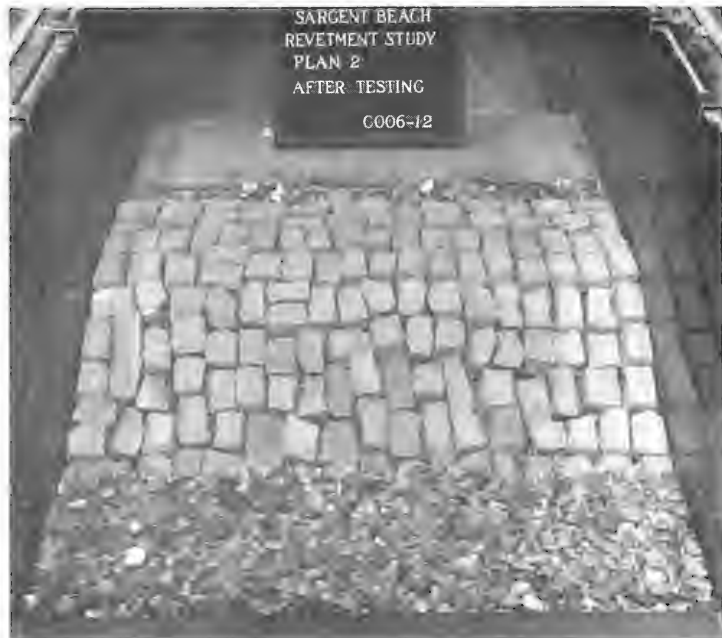
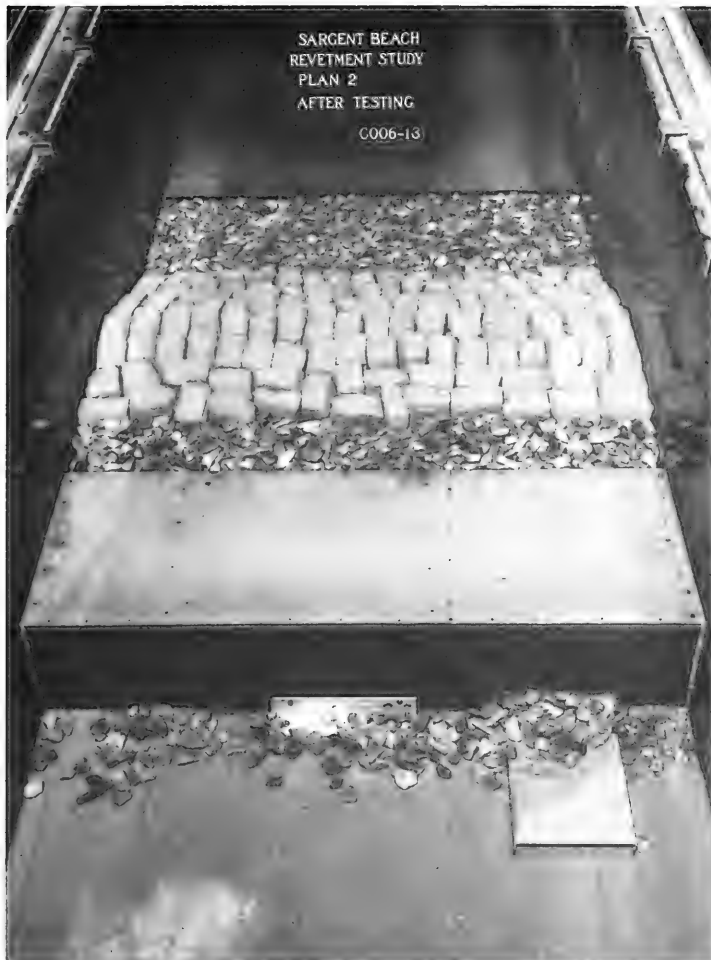
Photo 6. Side view of Plan 2 after wave attack

Photo 7. Sea-side view of Plan 2 after wave attack

Photo 8. Land-side view of Plan 2 after wave attack

Plan 2 was tested for the six-step storm given in Table 2. Only the +4-ft swl was tested, since this water level appeared to be the most critical to toe stability in previous tests of Plan 1. Plan 2 proved to be stable. Similar to Plan 1, minor reorientation of some 200- to 1,000-lb toe stone was observed. Also, several additional 200- to 1,000-lb stones were displaced from the shore-side crest of the structure. The after-testing condition of the structure is shown in Photos 6-8.

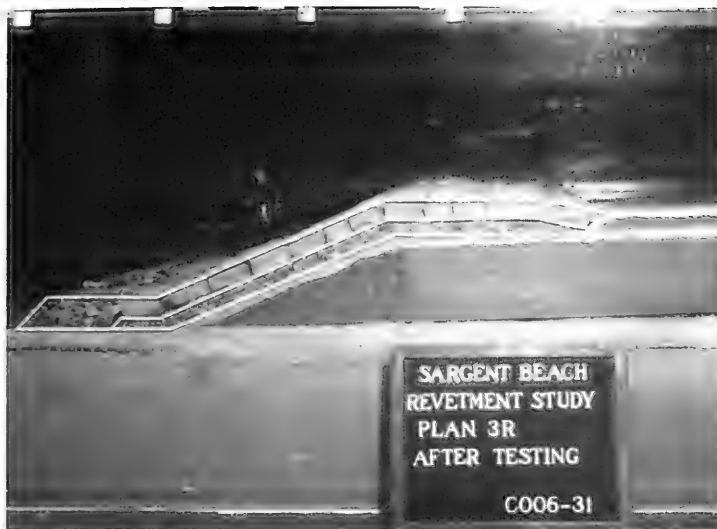
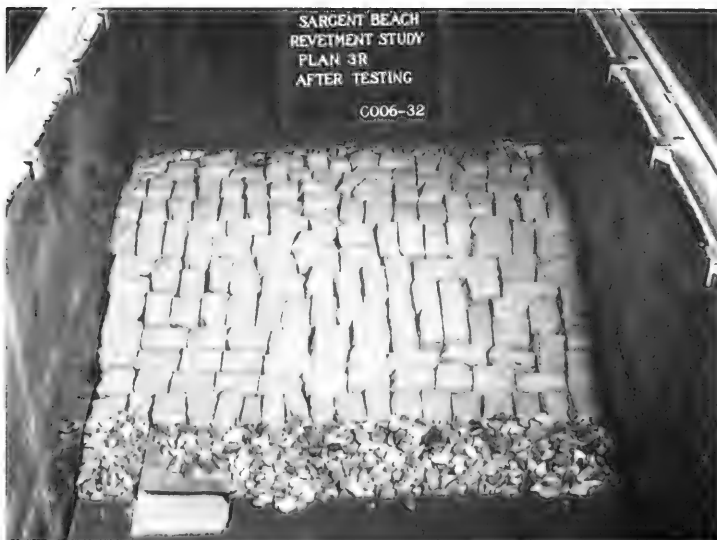
Photo 11. Side view of Plan 3R after wave attack

Photo 12. Sea-side view of Plan 3R after wave attack

Plan 3R was tested for the abbreviated worst case eight-step storm given in Table 4. Similar to previous plans, some reorientation of the 200- to 1,000-lb toe stone was observed and several 200- to 1,000-lb stones were displaced from the shore-side crest of the structure. The 5-ton armor was generally stable; however, one stone was displaced from the crest of the revetment during step 8 (Table 4 at the -8.6-ft mlt toe condition). The after-testing condition of the structure is shown in Photos 11 and 12.

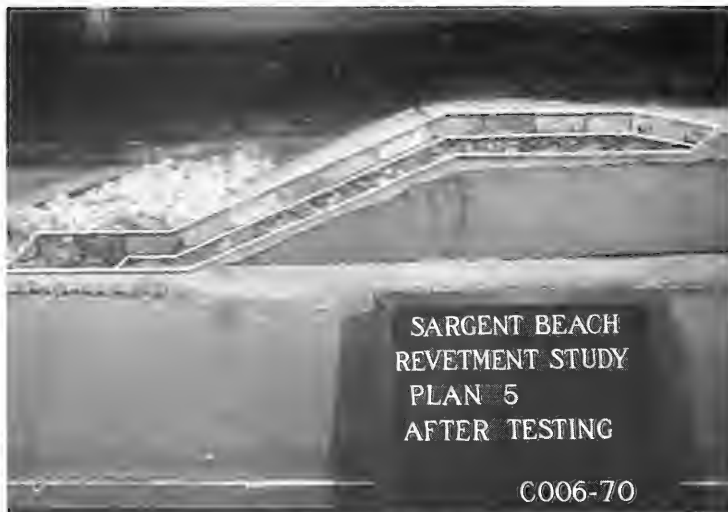
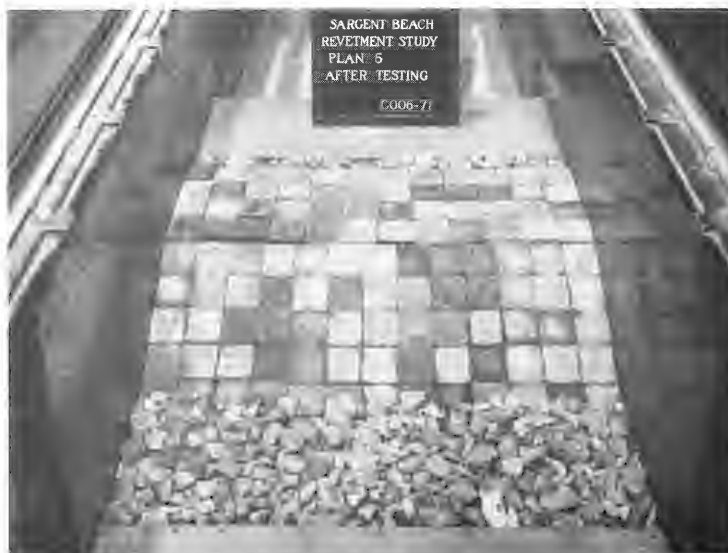
Photo 17. Side view of Plan 5 after wave attack

Photo 18. Sea-side view of Plan 5 after wave attack

Plan 5 (Figure 8) was similar to Plan 4 except it was assumed that the erosion depth in front of the structure was 5 ft less (sea bottom was raised from -8.6 ft mlt to -3.6 ft mlt). Also, the upper toe elevation was raised from -5.0 ft mlt to -3.6 ft mlt. Plan 5 was subjected to the same 24-step test as Plan 1 (Table 1). Testing at the +4-ft swl produced no movement of the concrete blocks. A few of the smaller 200- to 2,000-lb shore-side crest stones were displaced. Two additional crest stones were displaced during continued testing at the +7-, +9.5-, and +14-ft swls. No movement of the concrete blocks could be detected at any of the swl's. Photos 17 and 18 show the structure after wave attack.

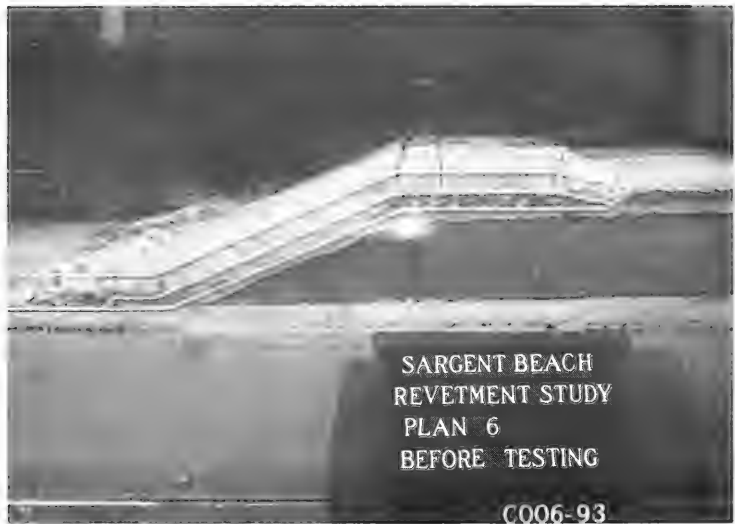
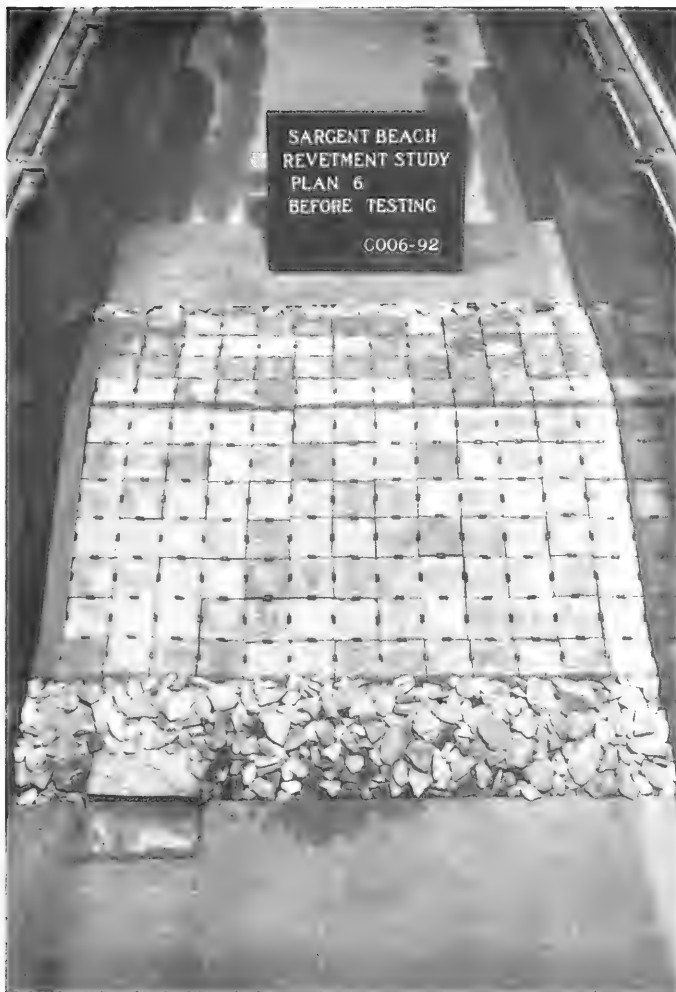
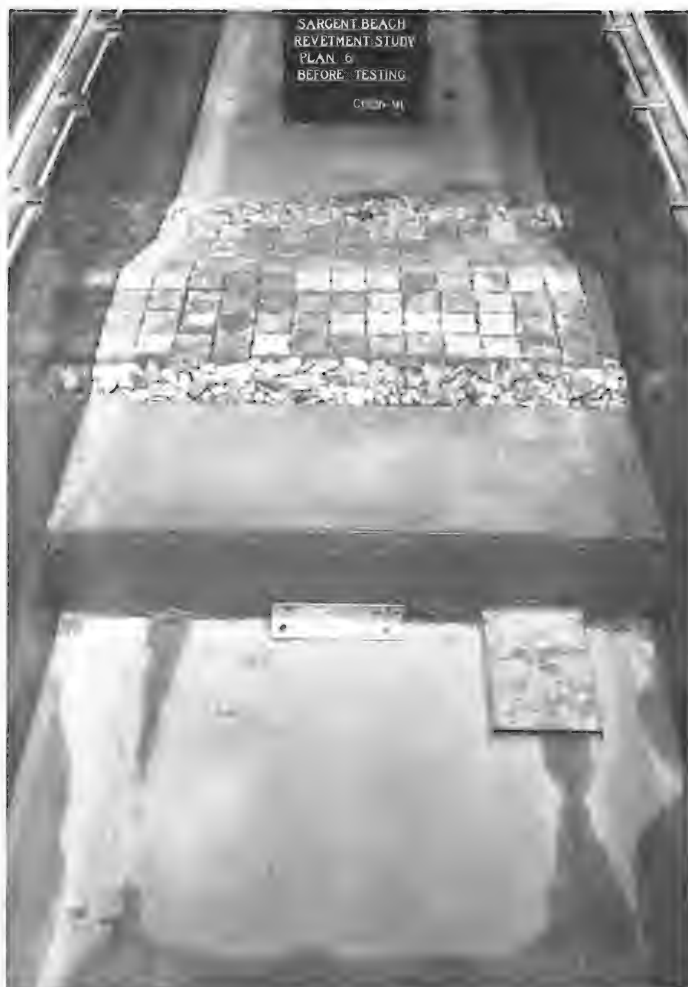
Photo 22. Side view of Plan 6 before wave attack

Photo 23. Sea-side view of Plan 6 before wave attack

Photo 24. Land-side view of Plan 6 before wave attack

Plan 6 (Figure 9 and Photos 22-24) was similar to Plans 4, 4R, 5, and 5R, except armoring was provided by 6.0-ton concrete blocks, 3.0-ft thick, 5.25-ft wide, and 5.25-ft long (Figure 10). The blocks were uniformly placed with their least dimension perpendicular to the slope. A 1.0-ft-long, 0.25-ft-wide and 3.0-ft-deep indentation was formed in each side of each block (Figure 10). The indentations served to increase the porosity of the block cover layer and reduce the buildup of pressures beneath the blocks. It was also felt that the

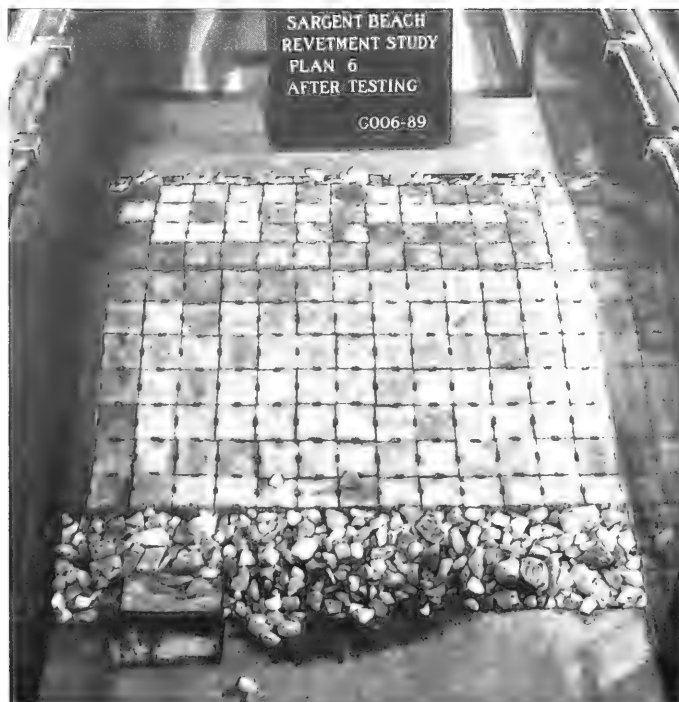
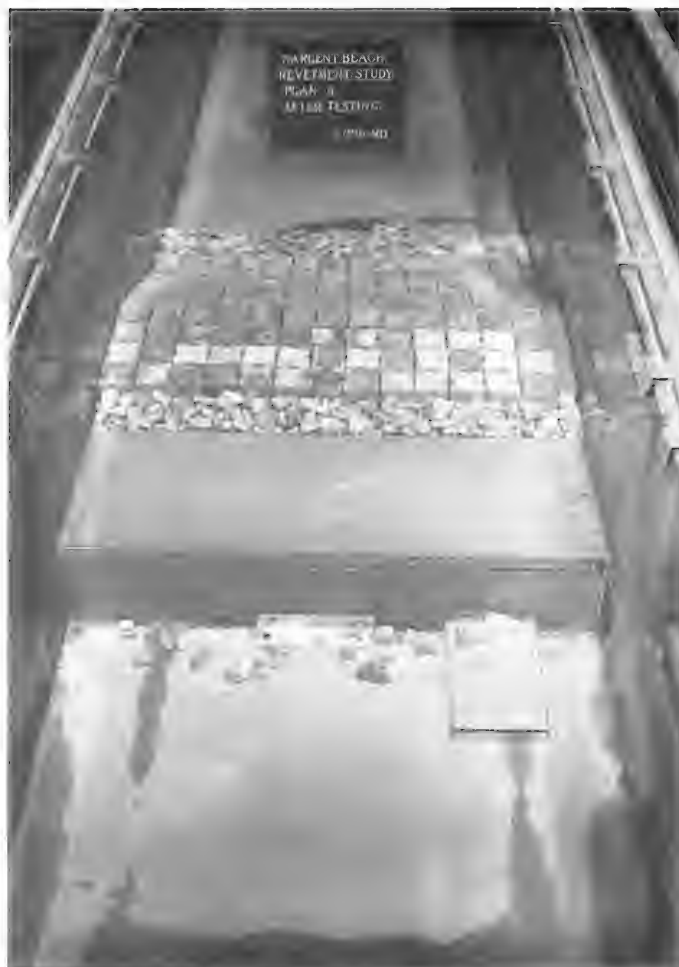
Photo 25. Side view of Plan 6 after testing

Photo 26. Sea-side view of Plan 6 after wave attack

Photo 27. Land-side view of Plan 6 after wave attack

Testing of Plans 1-6 showed wave conditions for the -8.6-ft mlt erosion depth to be significantly more severe than those observed at the -3.6-ft depth; therefore, stability tests for Plans 6 and 6R were conducted only at the -8.6-ft depth and it was assumed results could be conservatively applied to any lesser depth. Plan 6 was subjected to the 16-step test given in Table 5. The concrete blocks proved to be stable for all wave conditions; however, a few of the smaller 200- to 2,000-lb shore-side crest stones were displaced (Photos 25-27).

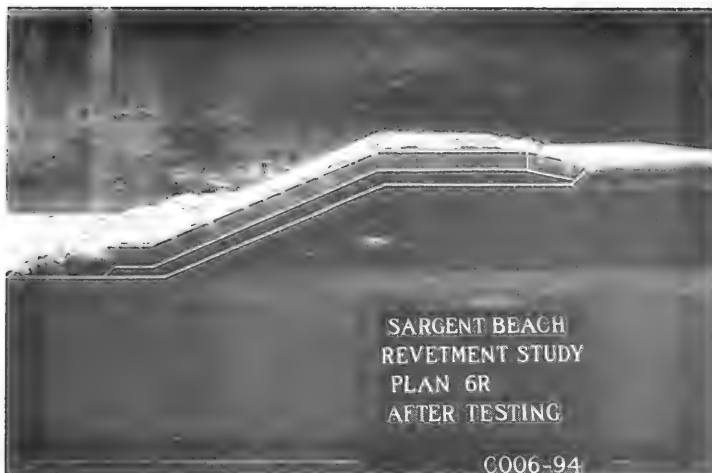
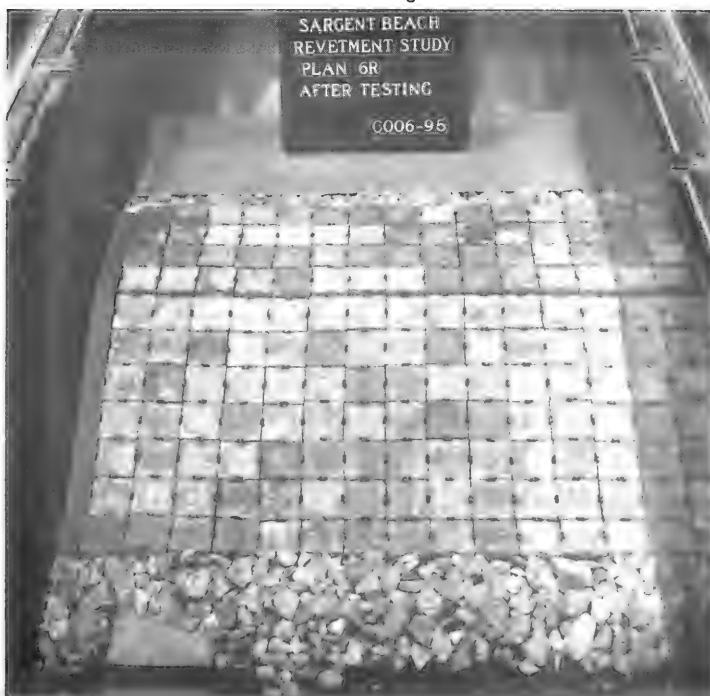
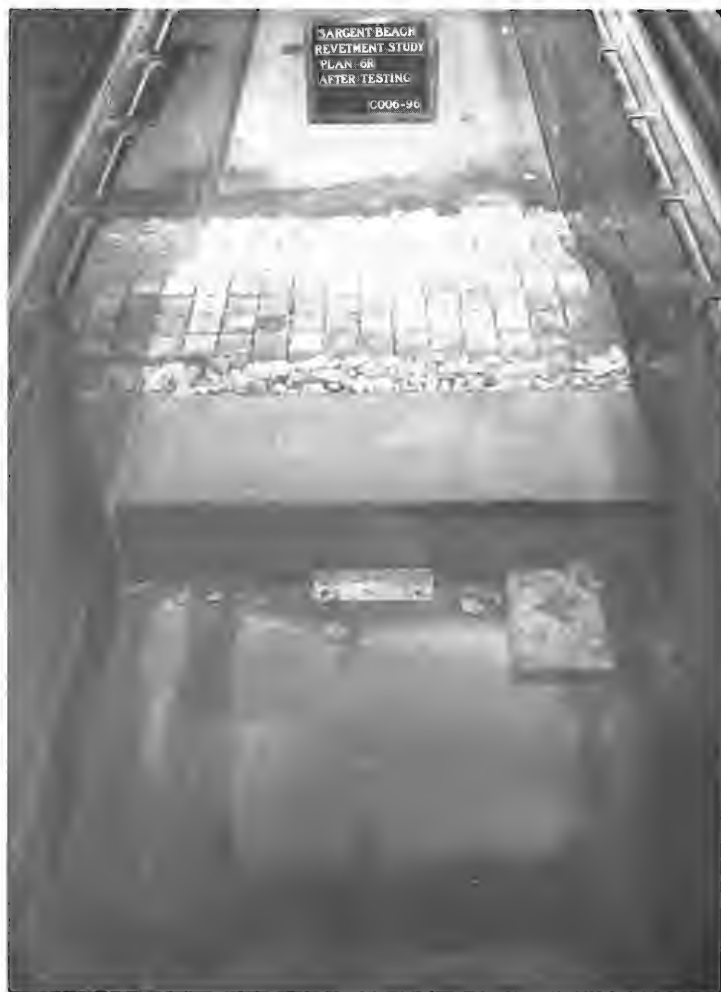
Photo 28. Side view of Plan 6R after testing

Photo 29. Sea-side view of Plan 6R after wave attack

Photo 30. Land-side view of Plan 6R after wave attack

Plan 6R (Figure 9) was a rebuild of Plan 6. It was tested to verify the stability response of the modified concrete blocks. Subjection to the abbreviated worst case hydrograph given in Table 4 produced the same results as the initial test, i.e., no movement of the concrete blocks was detected for any of the wave conditions. Photos 28-30 show the final condition of the test section.

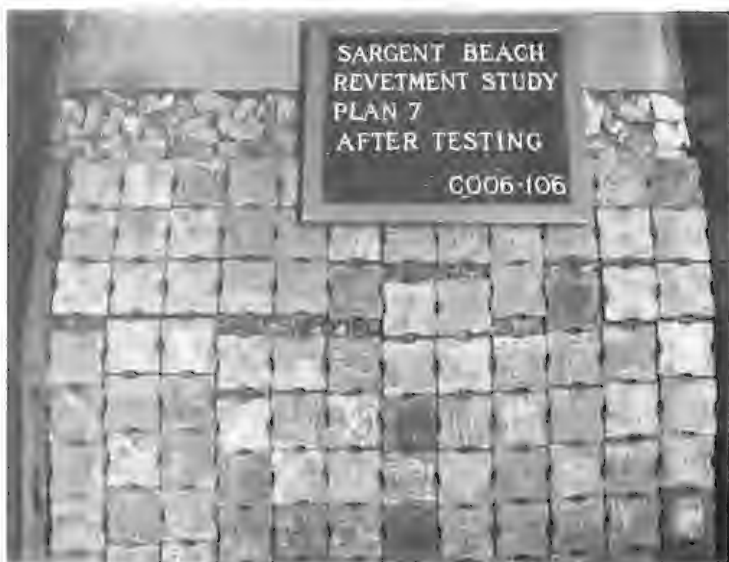
Photo 34. Overhead view of Plan 7 after wave attack

Plan 7 was subjected to the 20-step test given in Table 7. Slight seaward shifting of the first row of concrete blocks was initiated at the +4-ft swl. As the toe blocks shifted seaward, the six rows of onslope blocks packed downslope, leaving a gap between them and the three rows of crest blocks. This slow progressive movement continued through the +7-ft swl. At the conclusion of testing, the gap between the slope and crest blocks varied from a few inches to about 1.5 ft (prototype). Individual concrete blocks appeared to be hydraulically stable, i.e., no lifting or displacement was observed. Photos 31-33 show the overall condition of the section after wave attack and Photo 34 shows details of the block separation.

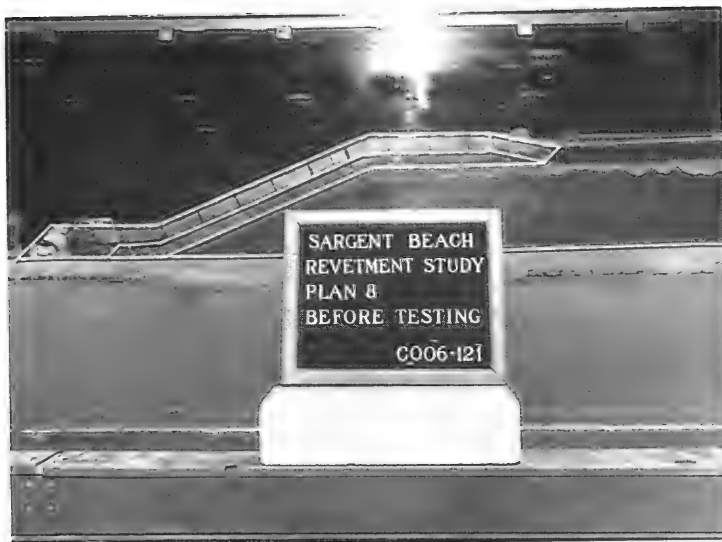
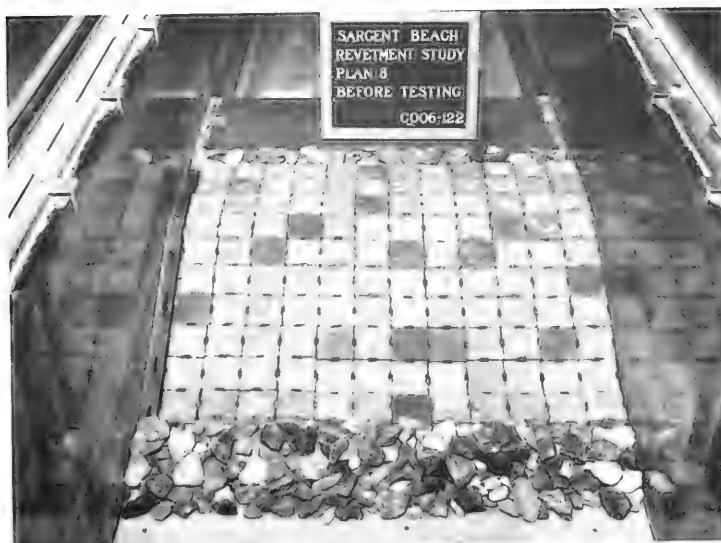
Photo 39. Side view of Plan 8 before wave attack

Photo 40. Sea-side view of Plan 8 before wave attack

Plan 8 (Figure 13 and Photos 39 and 40) was the same as Plan 7, except that the toe stone weight was increased to 200 to 4,000 lb in an effort to improve its stability and hopefully reduce sliding of the concrete blocks. Subjection to the same wave conditions as Plan 7 produced improved results; i.e., the toe stone was stable and the maximum gap between the slope and crest blocks was reduced to about 1 ft (prototype). Photos 41-44 show the structure after wave attack.

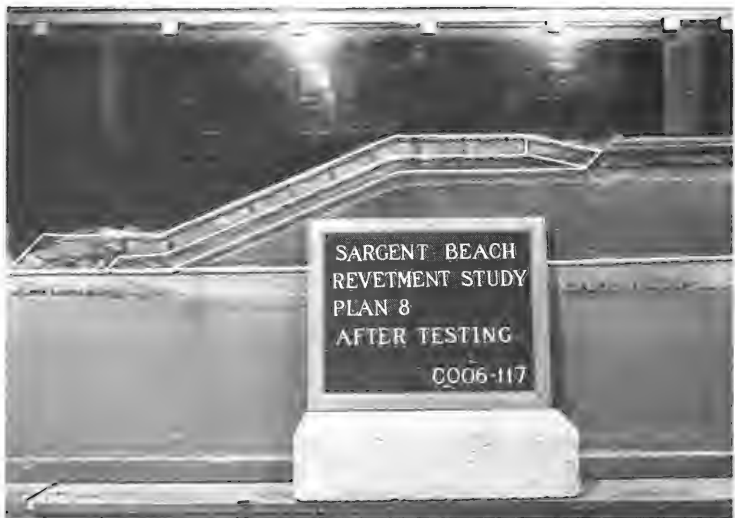
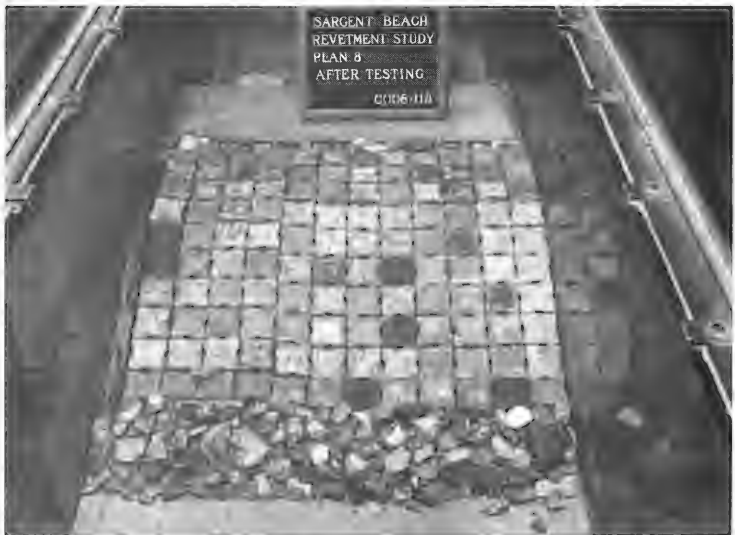
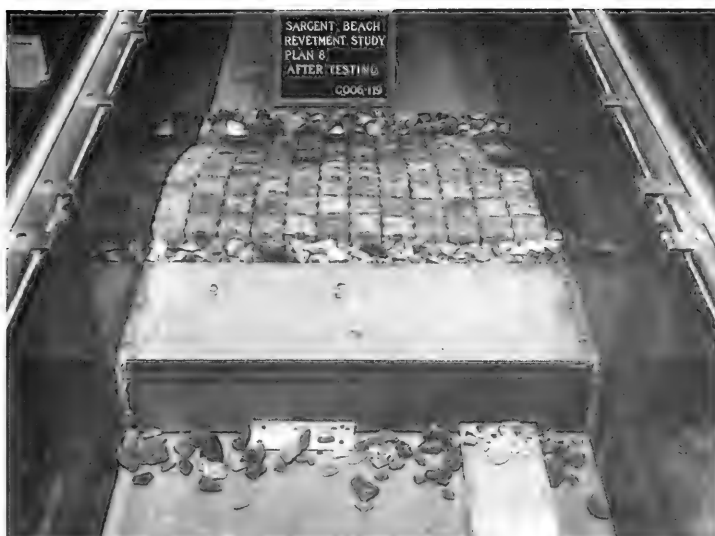
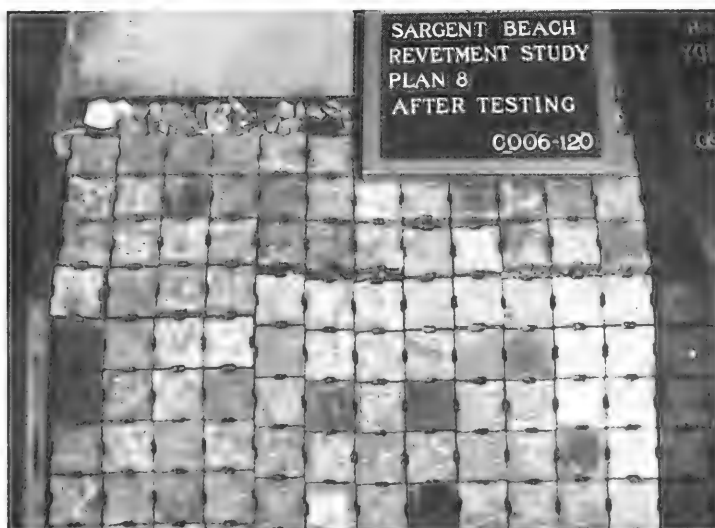
Photo 41. Side view of Plan 8 after wave attack

Photo 42. Sea-side view of Plan 8 after wave attack

Photo 43. Land-side view of Plan 8 after wave attack

Photo 44. Overhead view of Plan 8 after wave attack

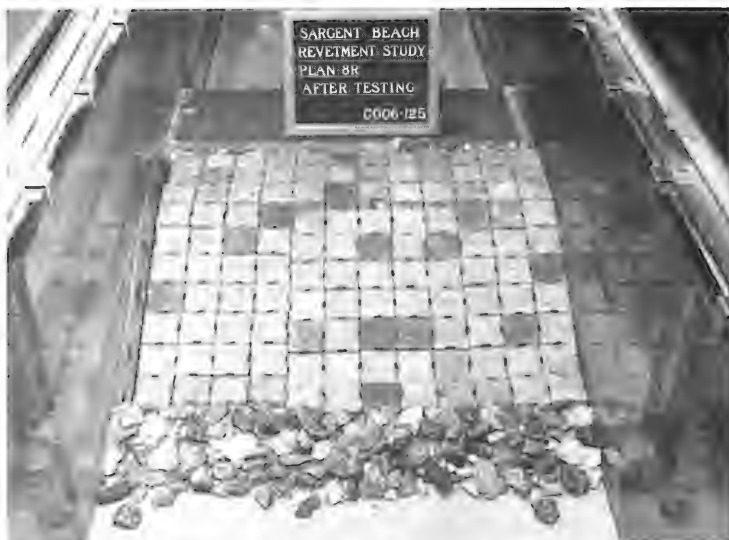
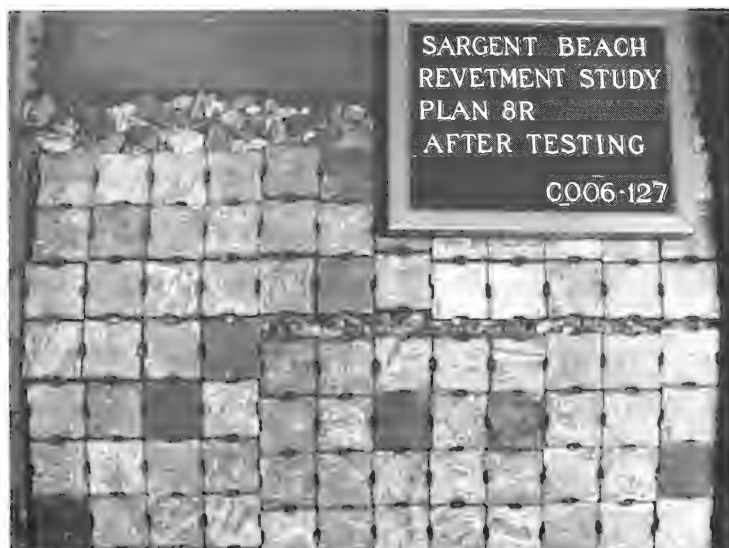
Photo 45. Sea-side view of Plan 8R after wave attack

Photo 46. Overhead view of Plan 8R after wave attack

Plan 8R (Figure 13) was a rebuild of Plan 8. Subjection to the hydrograph given in Table 8 verified results of the first test, i.e., a gap developed between the slope and crest blocks as a result of toe slippage and subsequent downslope slippage of the slope blocks. Again, no lifting or displacement of individual blocks was observed. Photos 45 and 46 show the final condition of the test section.
